FFI-rapport 2015/02397

# Sakkyndigrapport etter inspeksjon av et nikkel- metallhydridbatteri som hadde vært årsak til en brann

Forsvarets forskningsinstitutt (FFI)

5. februar 2016

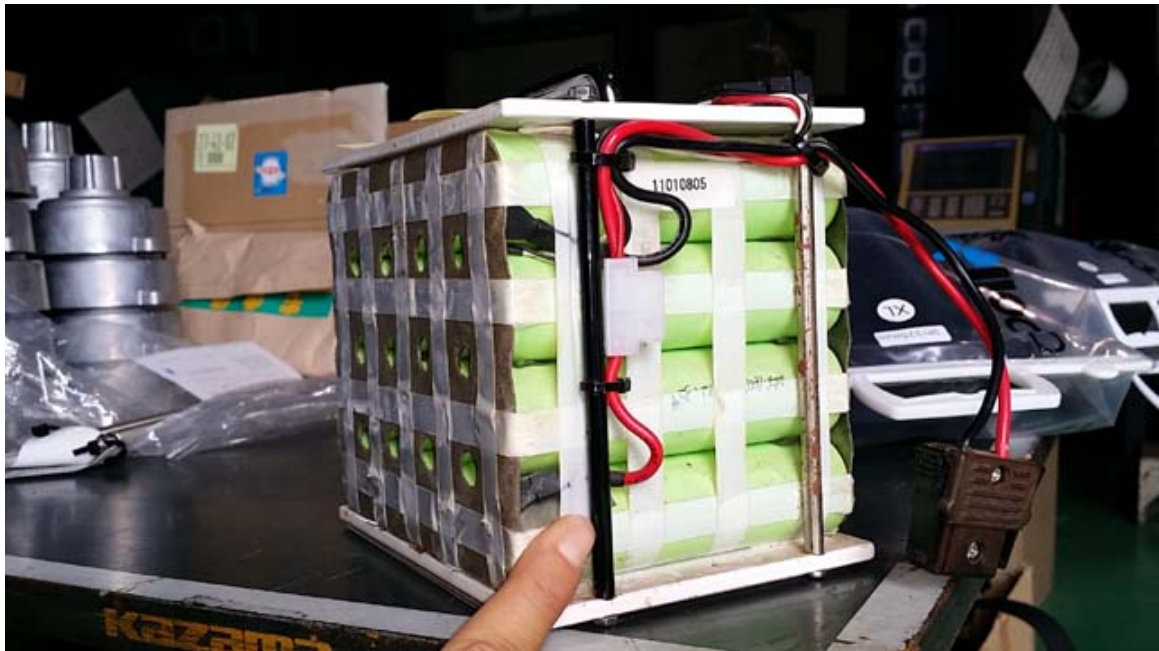
*Figur 4.1 Referansebatteri*

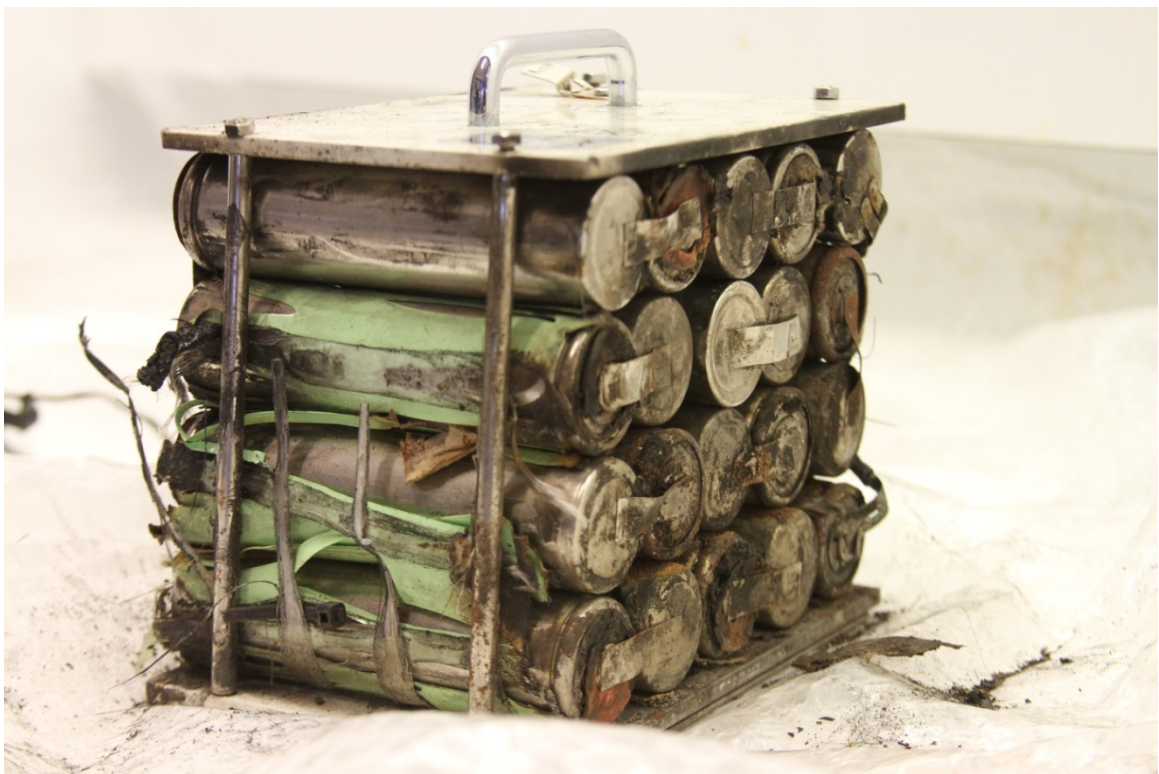
*Figur 4.2 Det utbrente batteriet. Celle 8 er satt tilbake i batteriet*

Det fremgår av bildene av det utbrente batteriet at temperaturen har vært høy.

Ved måling på cellene fant man at alle hadde en celledspenning nær  $0\text{ V}$ . De fleste hadde en motstand i området  $4$  til  $40\text{ ohm}$ , dvs. internt kortsluttet. Celle 2 veide f.eks  $298.4\text{ g}$  mot  $346\text{ g}$  i henhold til spesifikasjonen. Indre volum i cellen er  $102\text{ cm}^3$  slik at man kan anta at elektrolytten er kokt bort.

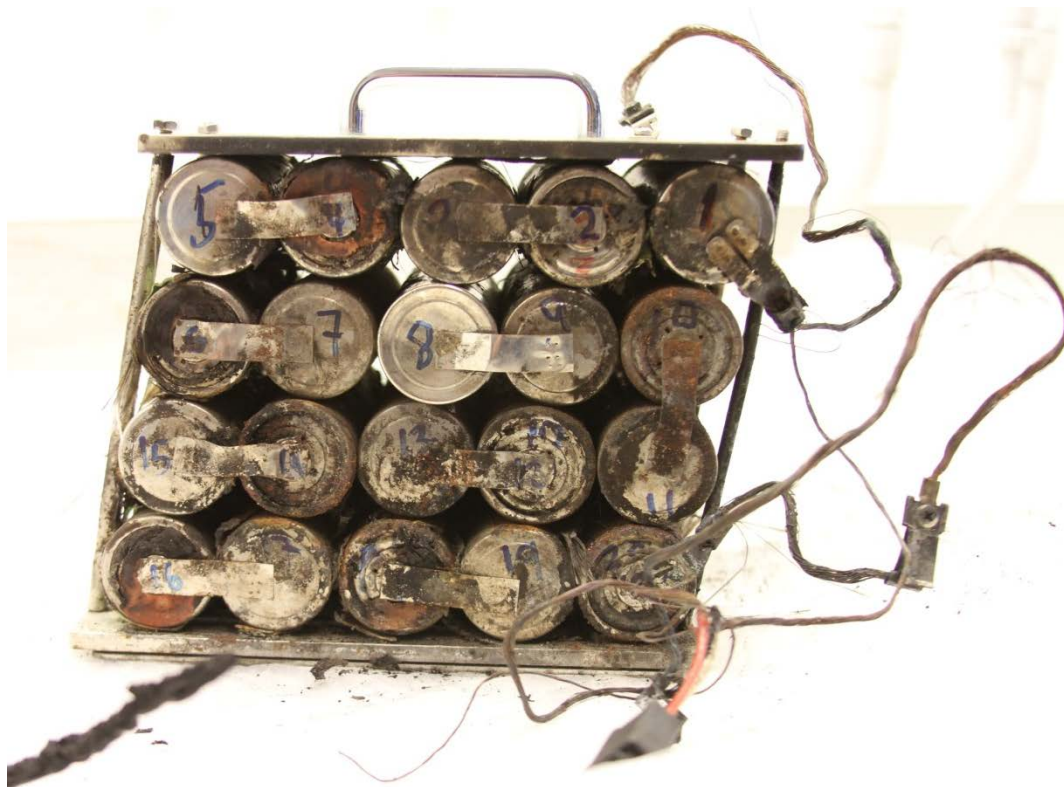
Figur 4.3 Cellene er nummerert fra 1 ved batteriets negative pol til 20 ved batteriets positive pol

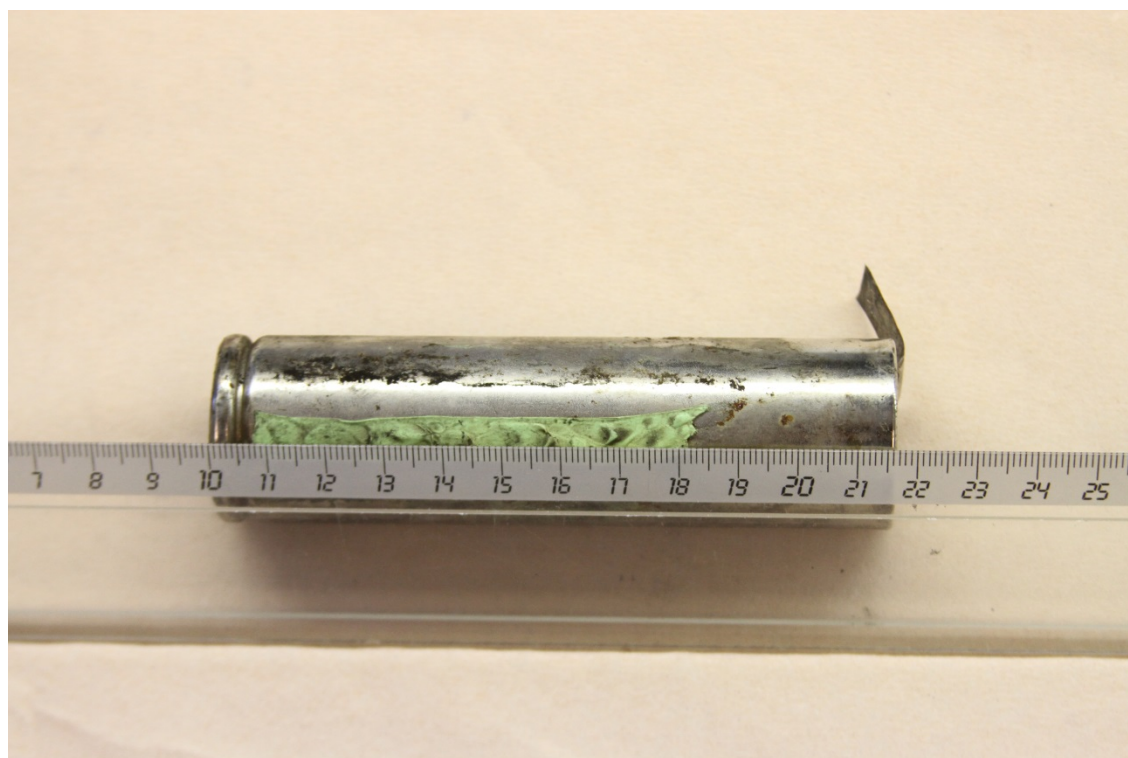
Figur 4.4 Celle nr. 8. Denne cellen blåste ut av batteriet og ble funnet i garasjeporten. Kannen er tom og lokket mangler. Bemerk at denne har lite rust, noe som sannsynliggjør at batteriet ikke har vært utsatt for en vannlekkasje.

Produsenten, Apollo, har bekreftet at tilsvarende har skjedd tidligere, men da på grunn av vann i batteriet som kjøler sensoren. Sjøvann i batteriet ville gitt korrosjon, noe som ikke ble observert (Den korrosjon som er observert kan forklares med vann fra slukkingen).

Ved at celle 8 ikke ventilerte kontrollert, men åpnet og tømte seg, ble pyrofort materiale eksponert mot luft og tok fyr.
