**SURVEILLANCE TEST OF PENGUIN MK2 MOD7
MOTOR S/N 202**

FFI/RAPPORT-2002/00284

SURVEILLANCE TEST OF PENGUIN MK2 MOD7 MOTOR S/N 202

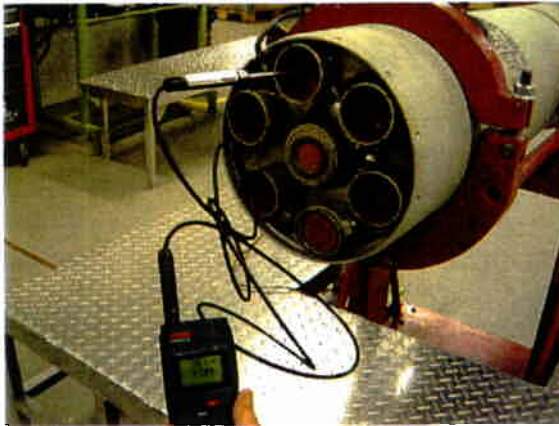
Humidity of the atmosphere in both the booster and sustainer motor was measured. The measurements were performed by entering into the motor through the nozzle weather seals by a long thin probe with 5 mm diameter. The weather seal consist of a thin glass-phenolic disc with silicone rubber inside. A small hole was drilled through the glass-phenolic disc and the probe was inserted through the silicone rubber and into the motor chamber. Accordingly the silicone rubber ensured sufficient sealing against the probe to avoid exchange of internal/external atmosphere.

The following pictures show how the measurements was performed:

The measured relative humidity and temperature data pairs were converted into absolute humidity (i.e. concentration) using a standard humidity table. The absolute humidity was approximately 4.5 grams of water per kg dry air inside the booster chamber and approximately 4.3 grams of water per kg dry air inside the sustainer chamber.

The following leakage test and measurements of water content in the booster and sustainer propellants (approximately 0.02wt% water) showed that the seals were intact and that the bulk of the propellant grains had not been subjected to moist conditions.

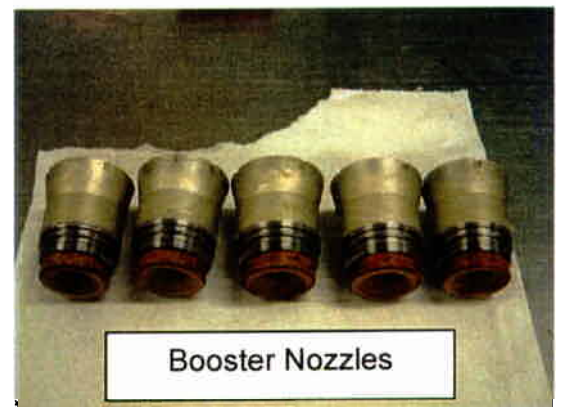
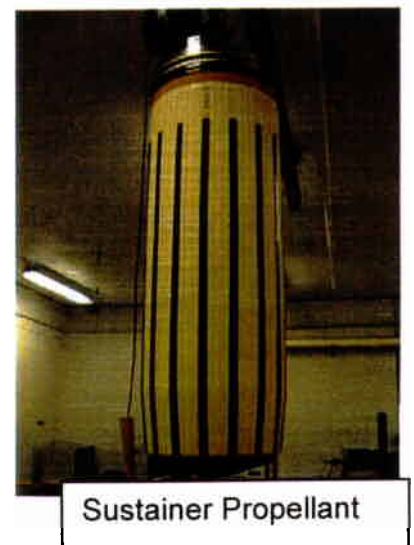
The motor was disassembled and components visually inspected, no irregularities were observed. The following pictures show motor components during and after disassembly:

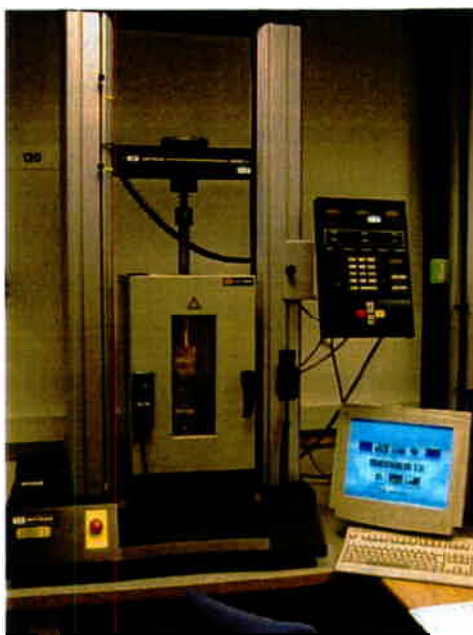
Figure 5.6.5.1: Instron 4465 Tensile Test Machine

Test specimens were cut out from propellant part no 2 in the lengthwise direction of the motor.

Cross head speed was 50 mm/min and temperature -40 , $+21$, and 63°C . At each temperature 5 specimens were tested.

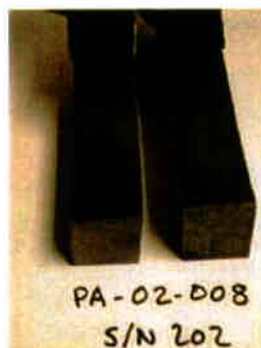
The different result compared to the production control in 1993 can be explained by difference in test samples. The peel test samples taken from the sustainer grain in motor s/n 202 had a bondline with a diameter of $\varnothing 260$ while the production sample from 1993 had a plane bondline.

Picture showing peel test samples from sustainer grain of motor s/n 202. Samples are taken in the lengthwise direction of motor with a bondline diameter of $\varnothing 260\text{mm}$.
